**40-YEAR AND OLDER BUILDING SAFETY INSPECTION**

**PROJECT:**  
THREE-STORY BUILDING  
FOLIO NO: 484110AC

**ADDRESS:**  
5701 RIVERSIDE DRIVE  
CORAL SPRINGS, FL 33067

**NOVEMBER 23, 2023**

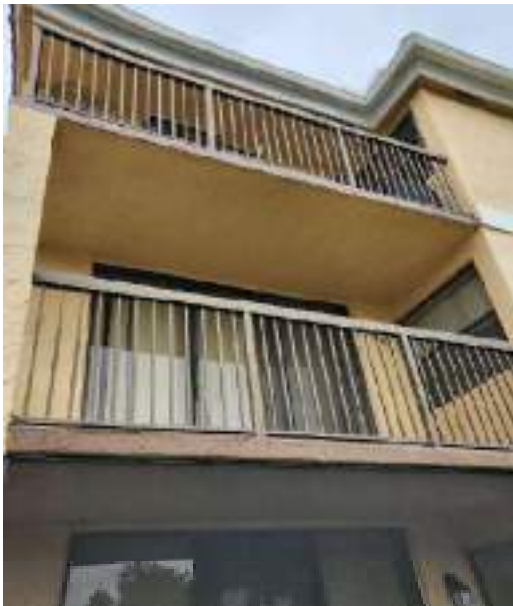
**Railings and balconies (Good condition)**

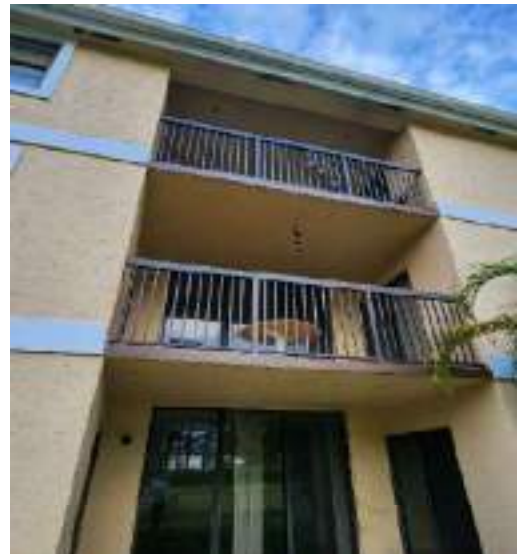
**Railings and balconies (Good condition)**

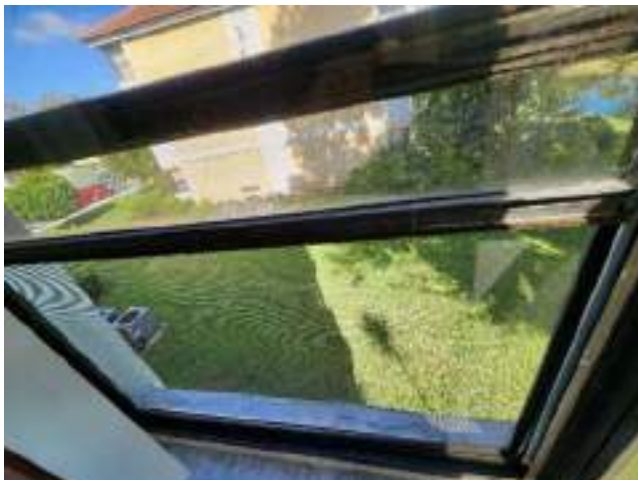
**Exterior Windows (Good condition)**

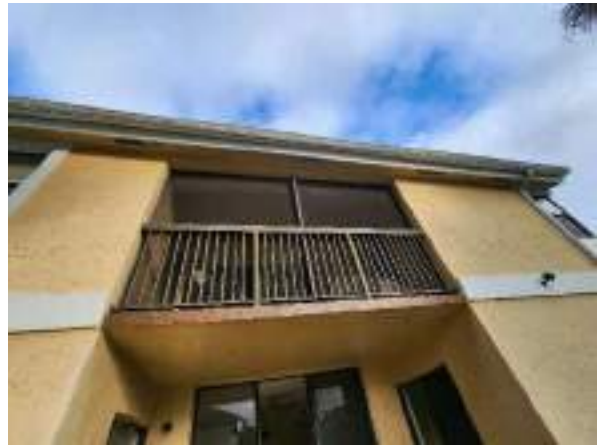
**Railings and balconies (Fair condition)**

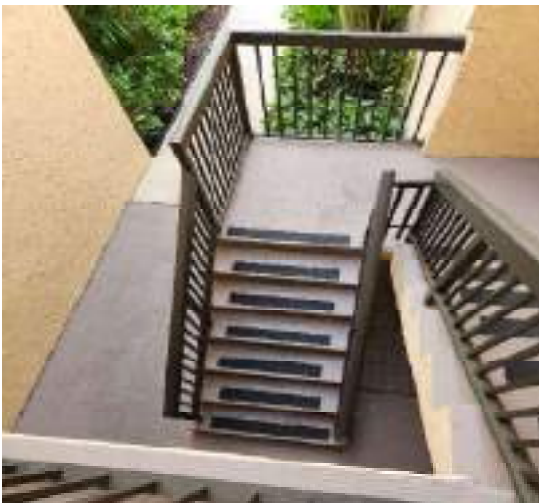
**Stairs and railings (Fair condition)**

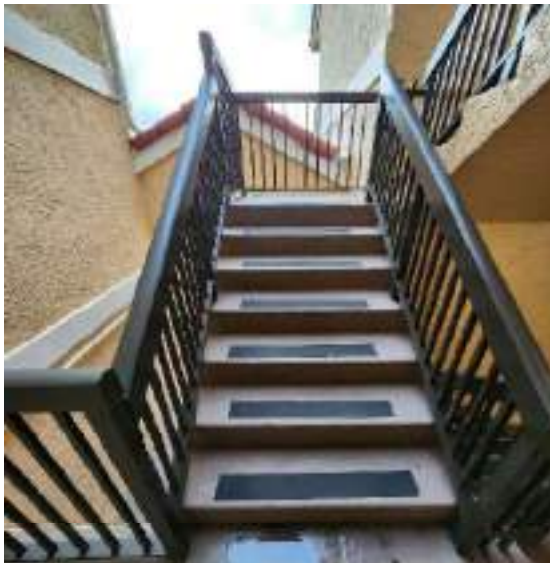
**Stairs and railings (Fair condition)**

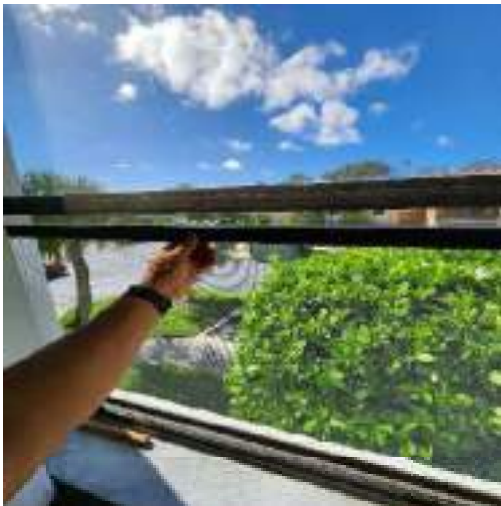
**Exterior windows (Fair condition)**

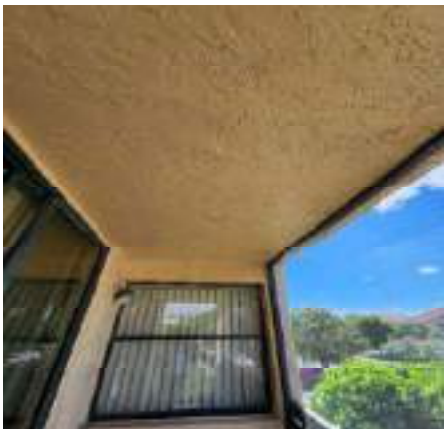
**Balconies (Fair condition)**

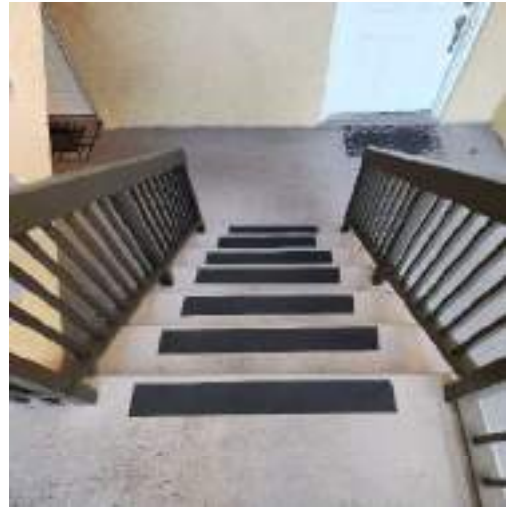
**Stairs and railings (Fair condition)**

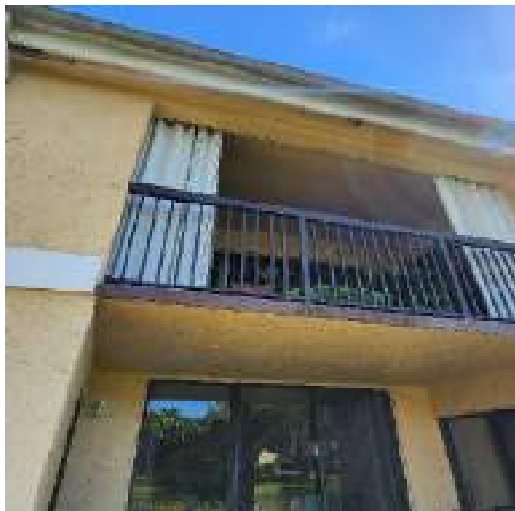
**Balconies (Fair condition)**

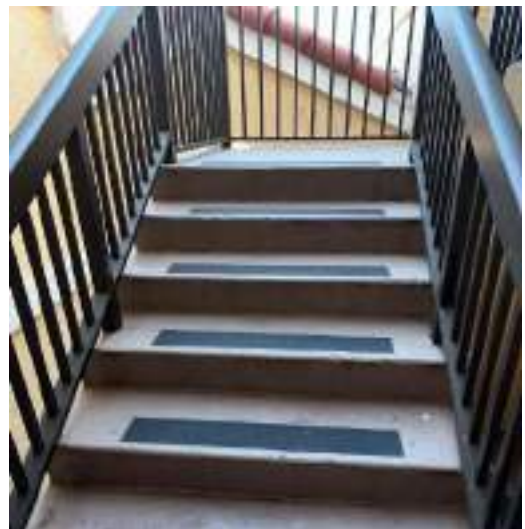
**Stairs and railings (Fair condition)**

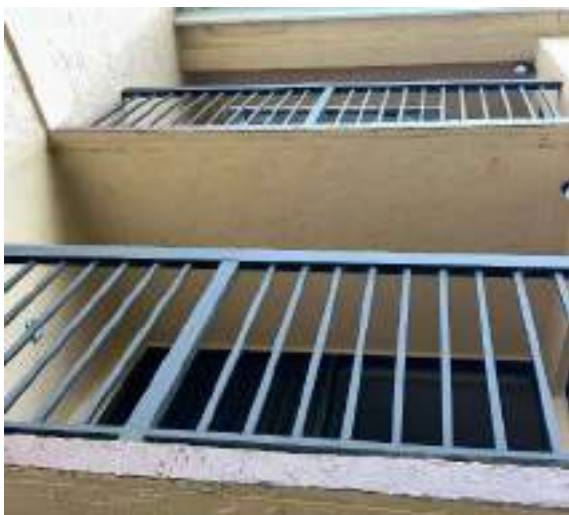
**Balconies (Fair condition)**

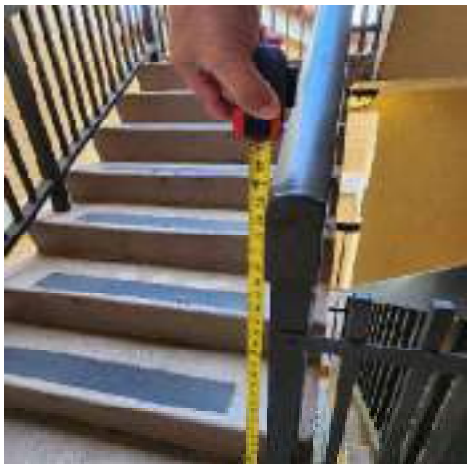
**Stairs and railings (Fair condition)**

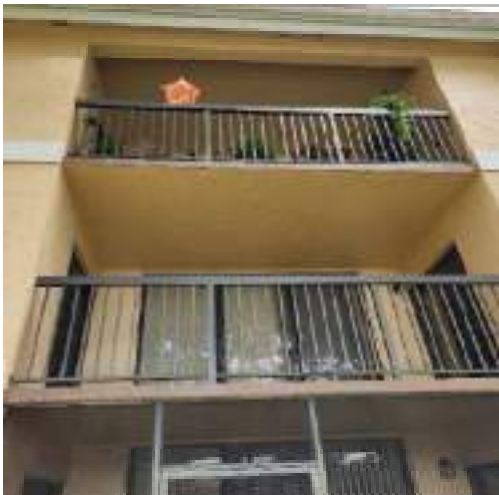
**Balconies (Fair condition)**

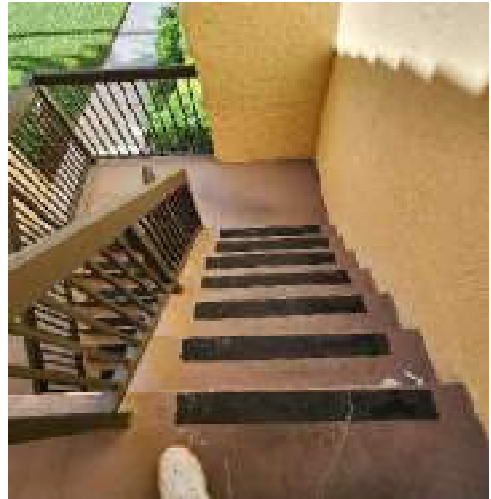
**Stairs and railings (Fair condition)**

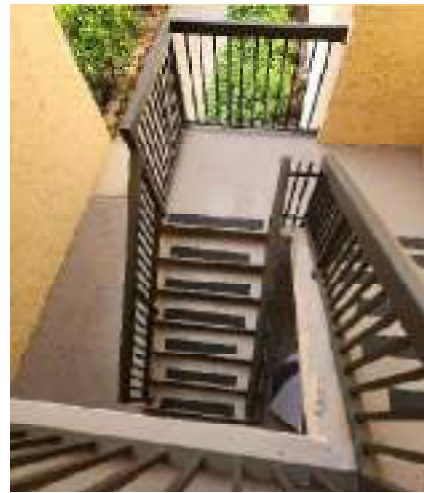
**Stairs and railings (Fair condition)**

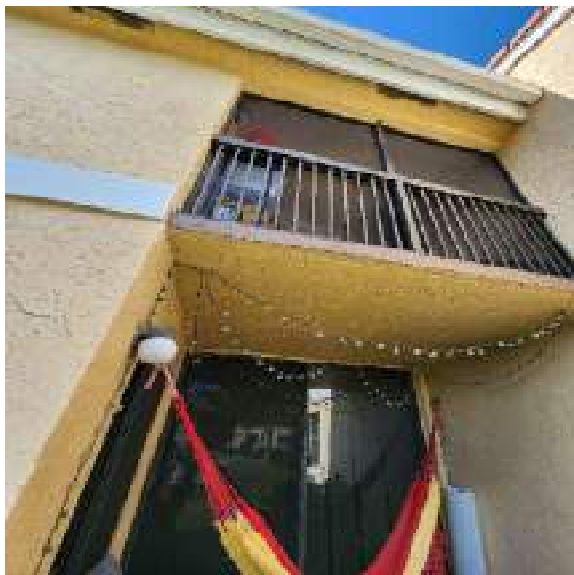
**Balconies (Fair condition)**

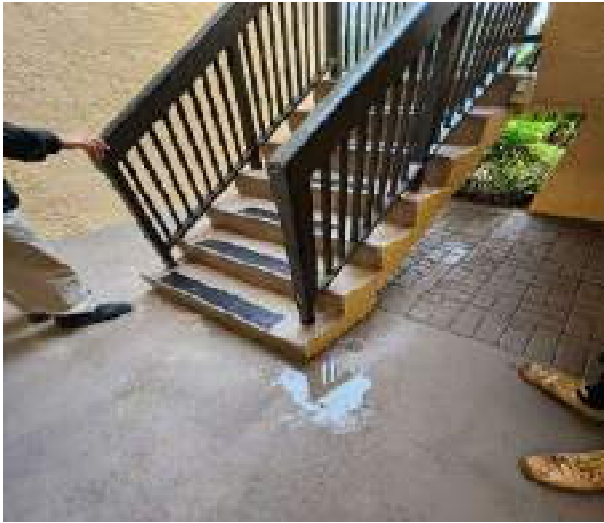
**Railings (Good condition)**

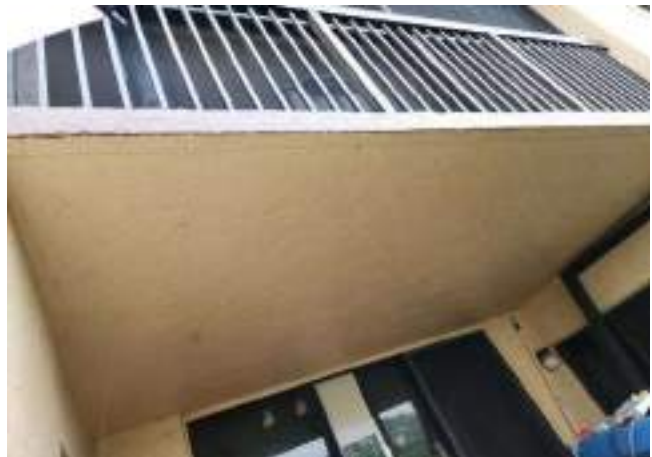
**Balconies (Good condition)**

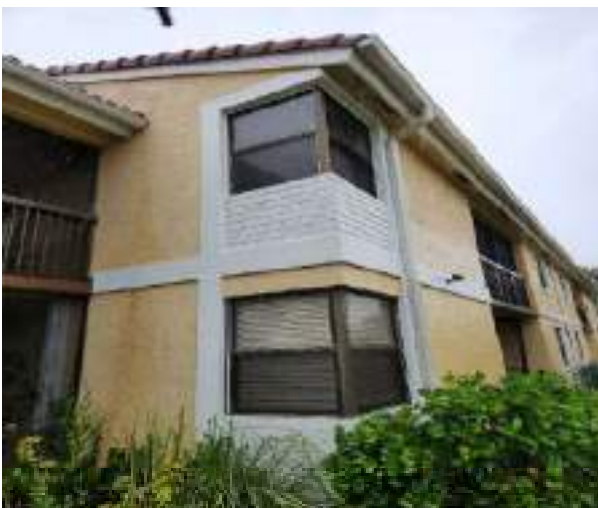
**Exterior Windows (Good condition)**

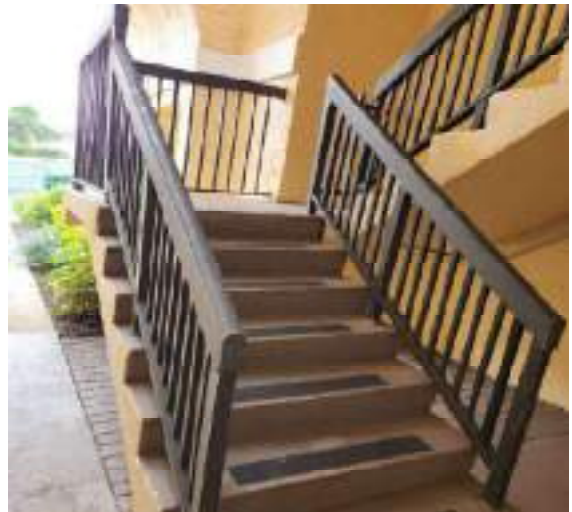
**Railings (Good condition)**

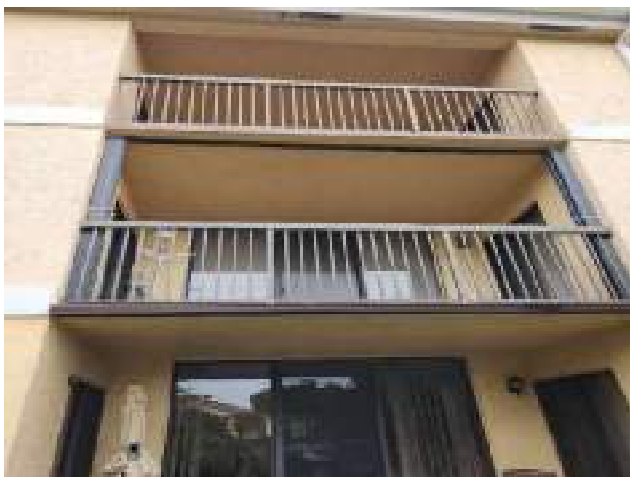
**Balconies (Good condition)**

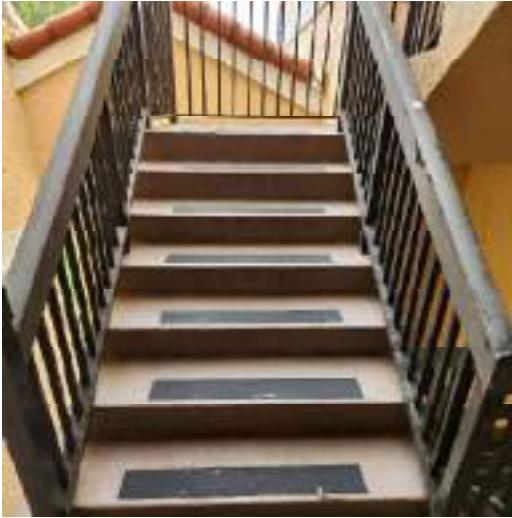
**Railings (Good condition)**

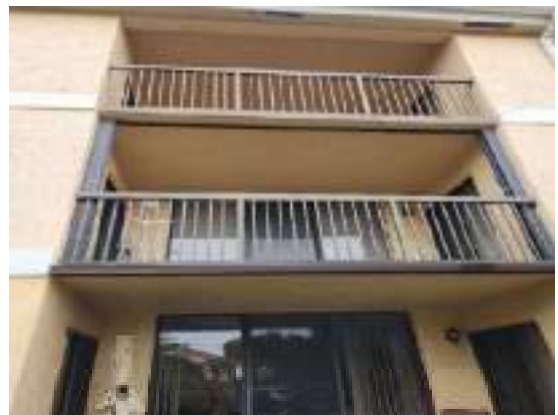
**Balconies (Good condition)**

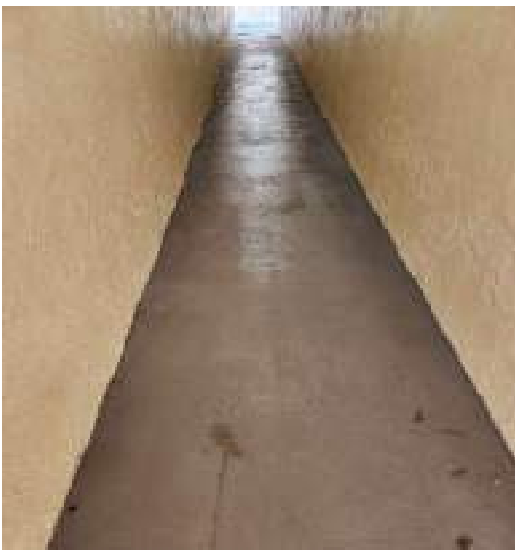
**Corridors (Good condition)**

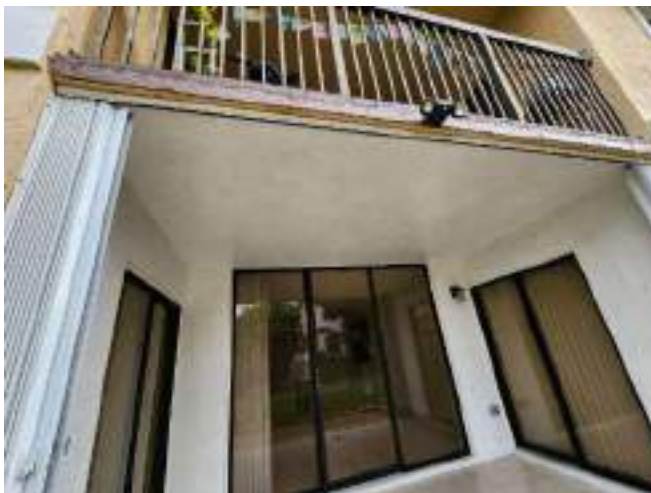
**Railings and balconies (Good condition)**
