**40-YEAR AND OLDER BUILDING SAFETY INSPECTION**

**PROJECT:**  
THREE-STORY BUILDING  
FOLIO NO: 484110AC

**ADDRESS:**  
5701 RIVERSIDE DRIVE  
CORAL SPRINGS, FL 33067

**NOVEMBER 23, 2023**

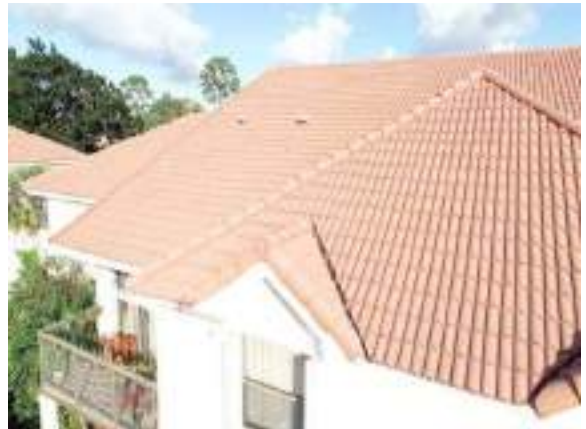
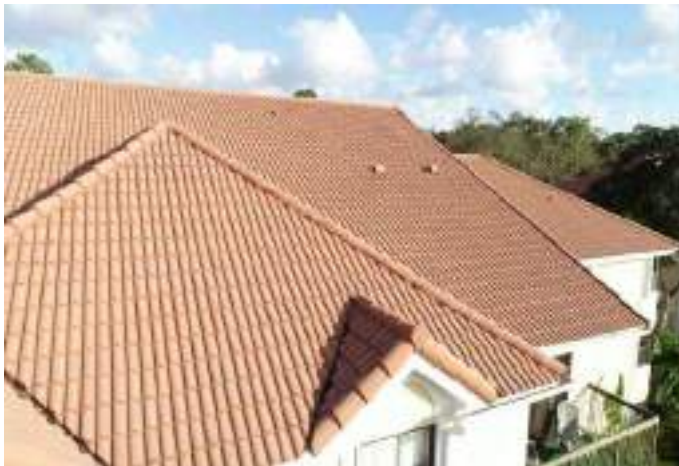
1. Describe the Type and Condition of the Current Roof:  
Prefabricated wood trusses with hipped tile roof in fair condition

**General Roof Pictures**

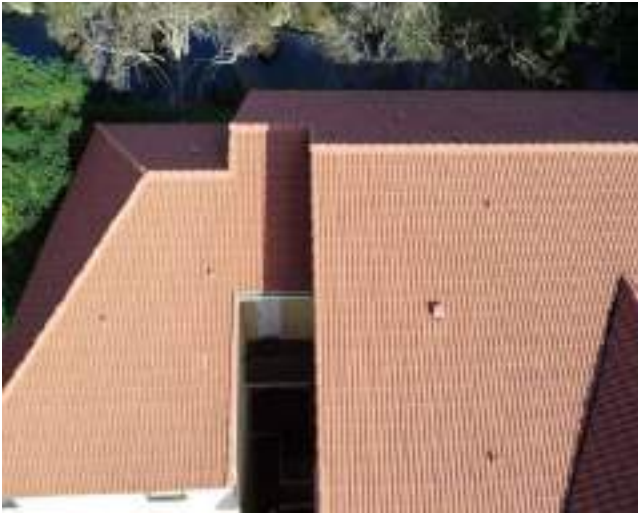
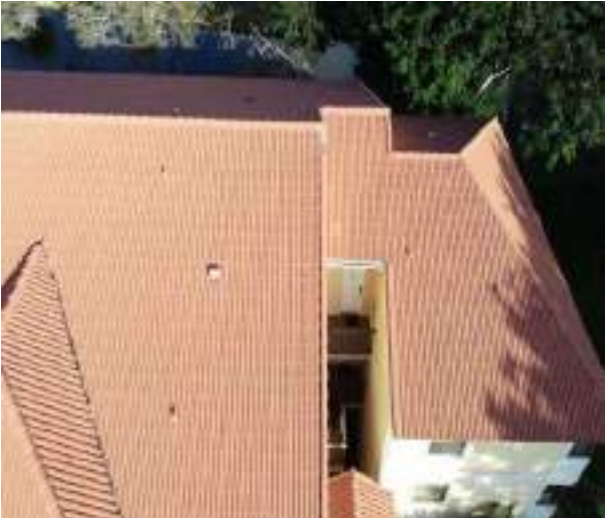
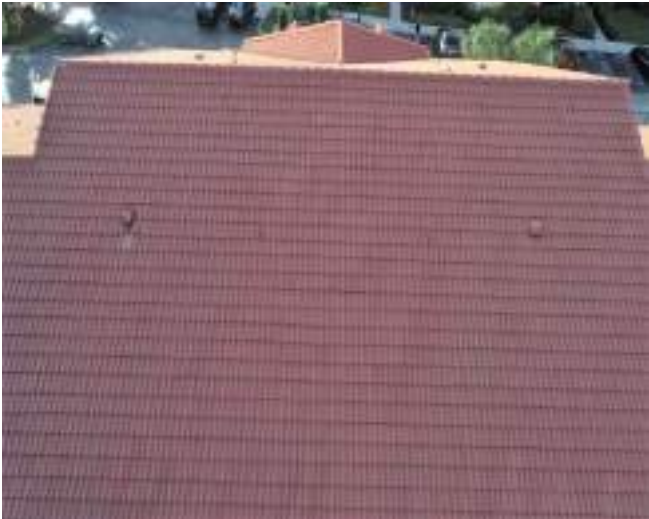
General Roof Pictures

1. Describe the Type and Condition of the Current Roof:  
Prefabricated wood trusses with hipped tile roof in fair condition

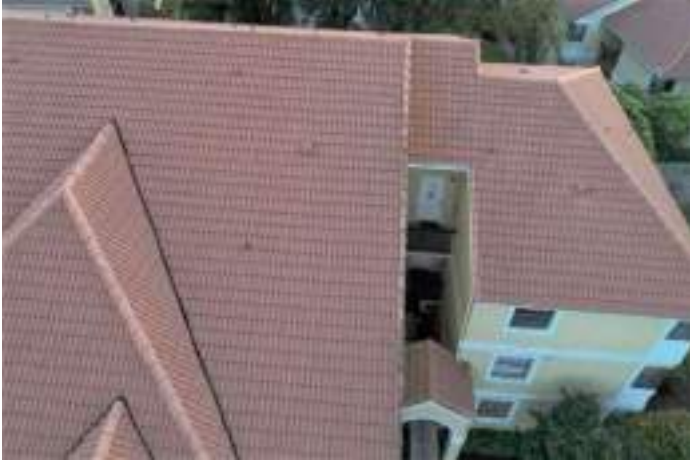
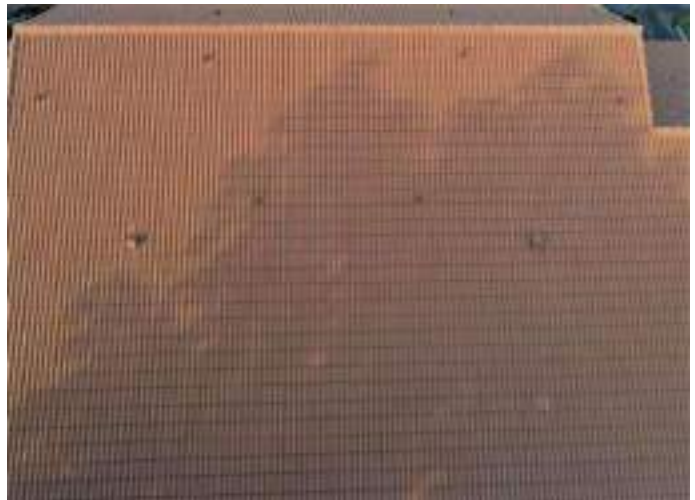
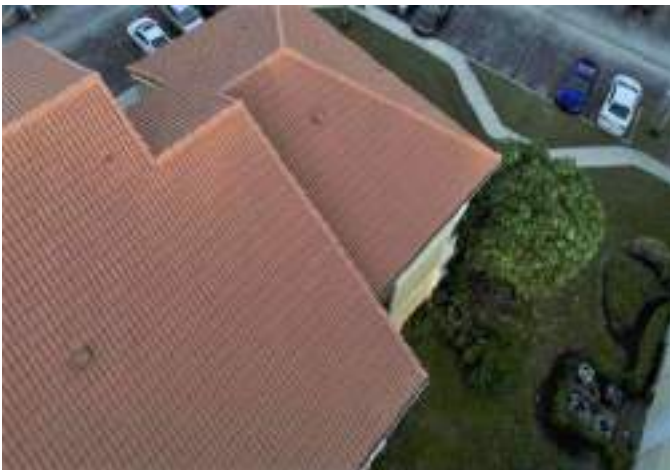
General Roof Pictures

1. Describe the Type and Condition of the Current Roof:  
Prefabricated wood trusses with hipped tile roof in fair condition

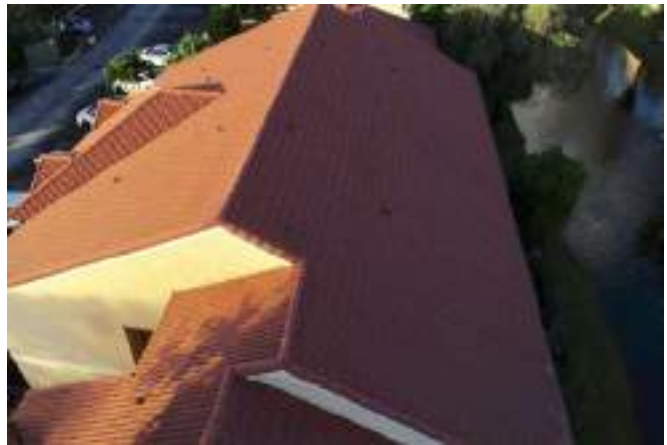
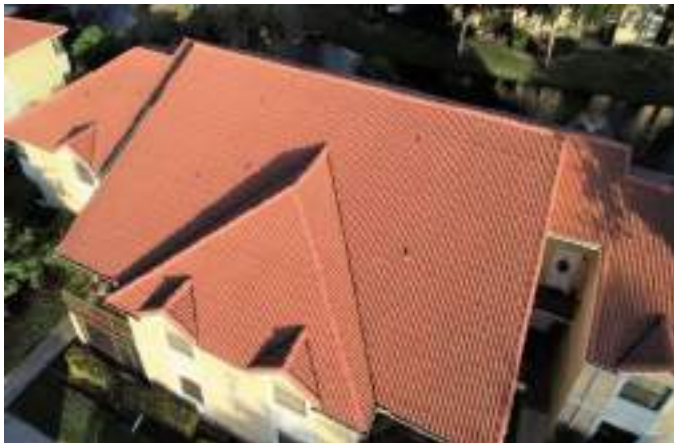
**General Roof Pictures**

Prefabricated wood trusses with hipped tile roof in fair condition

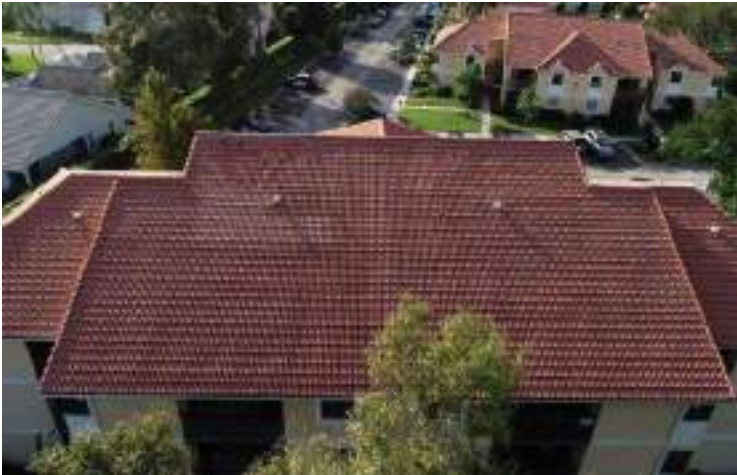
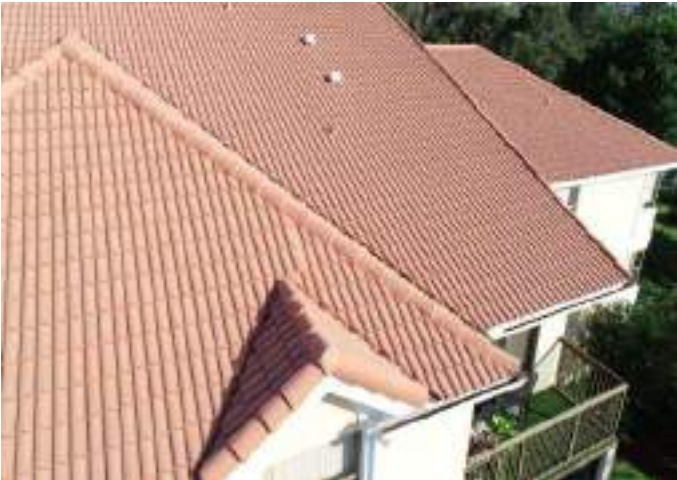
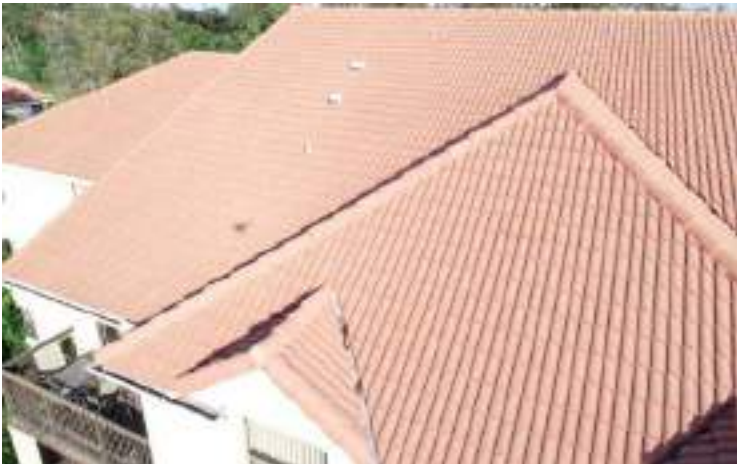
General Roof Pictures

1. Describe the Type and Condition of the Current Roof:  
Prefabricated wood trusses with hipped tile roof in fair condition
